Discontinuation of Contingency Monitoring Report for MP-8F St. Bernard Landfill

Prepared for:
Village of St. Bernard

Prepared by:
SCS Engineers
2060 Reading Road, Suite 200
Cincinnati, OH 45202
(513) 421-5353

December 22, 2015
File No. 23212007.03

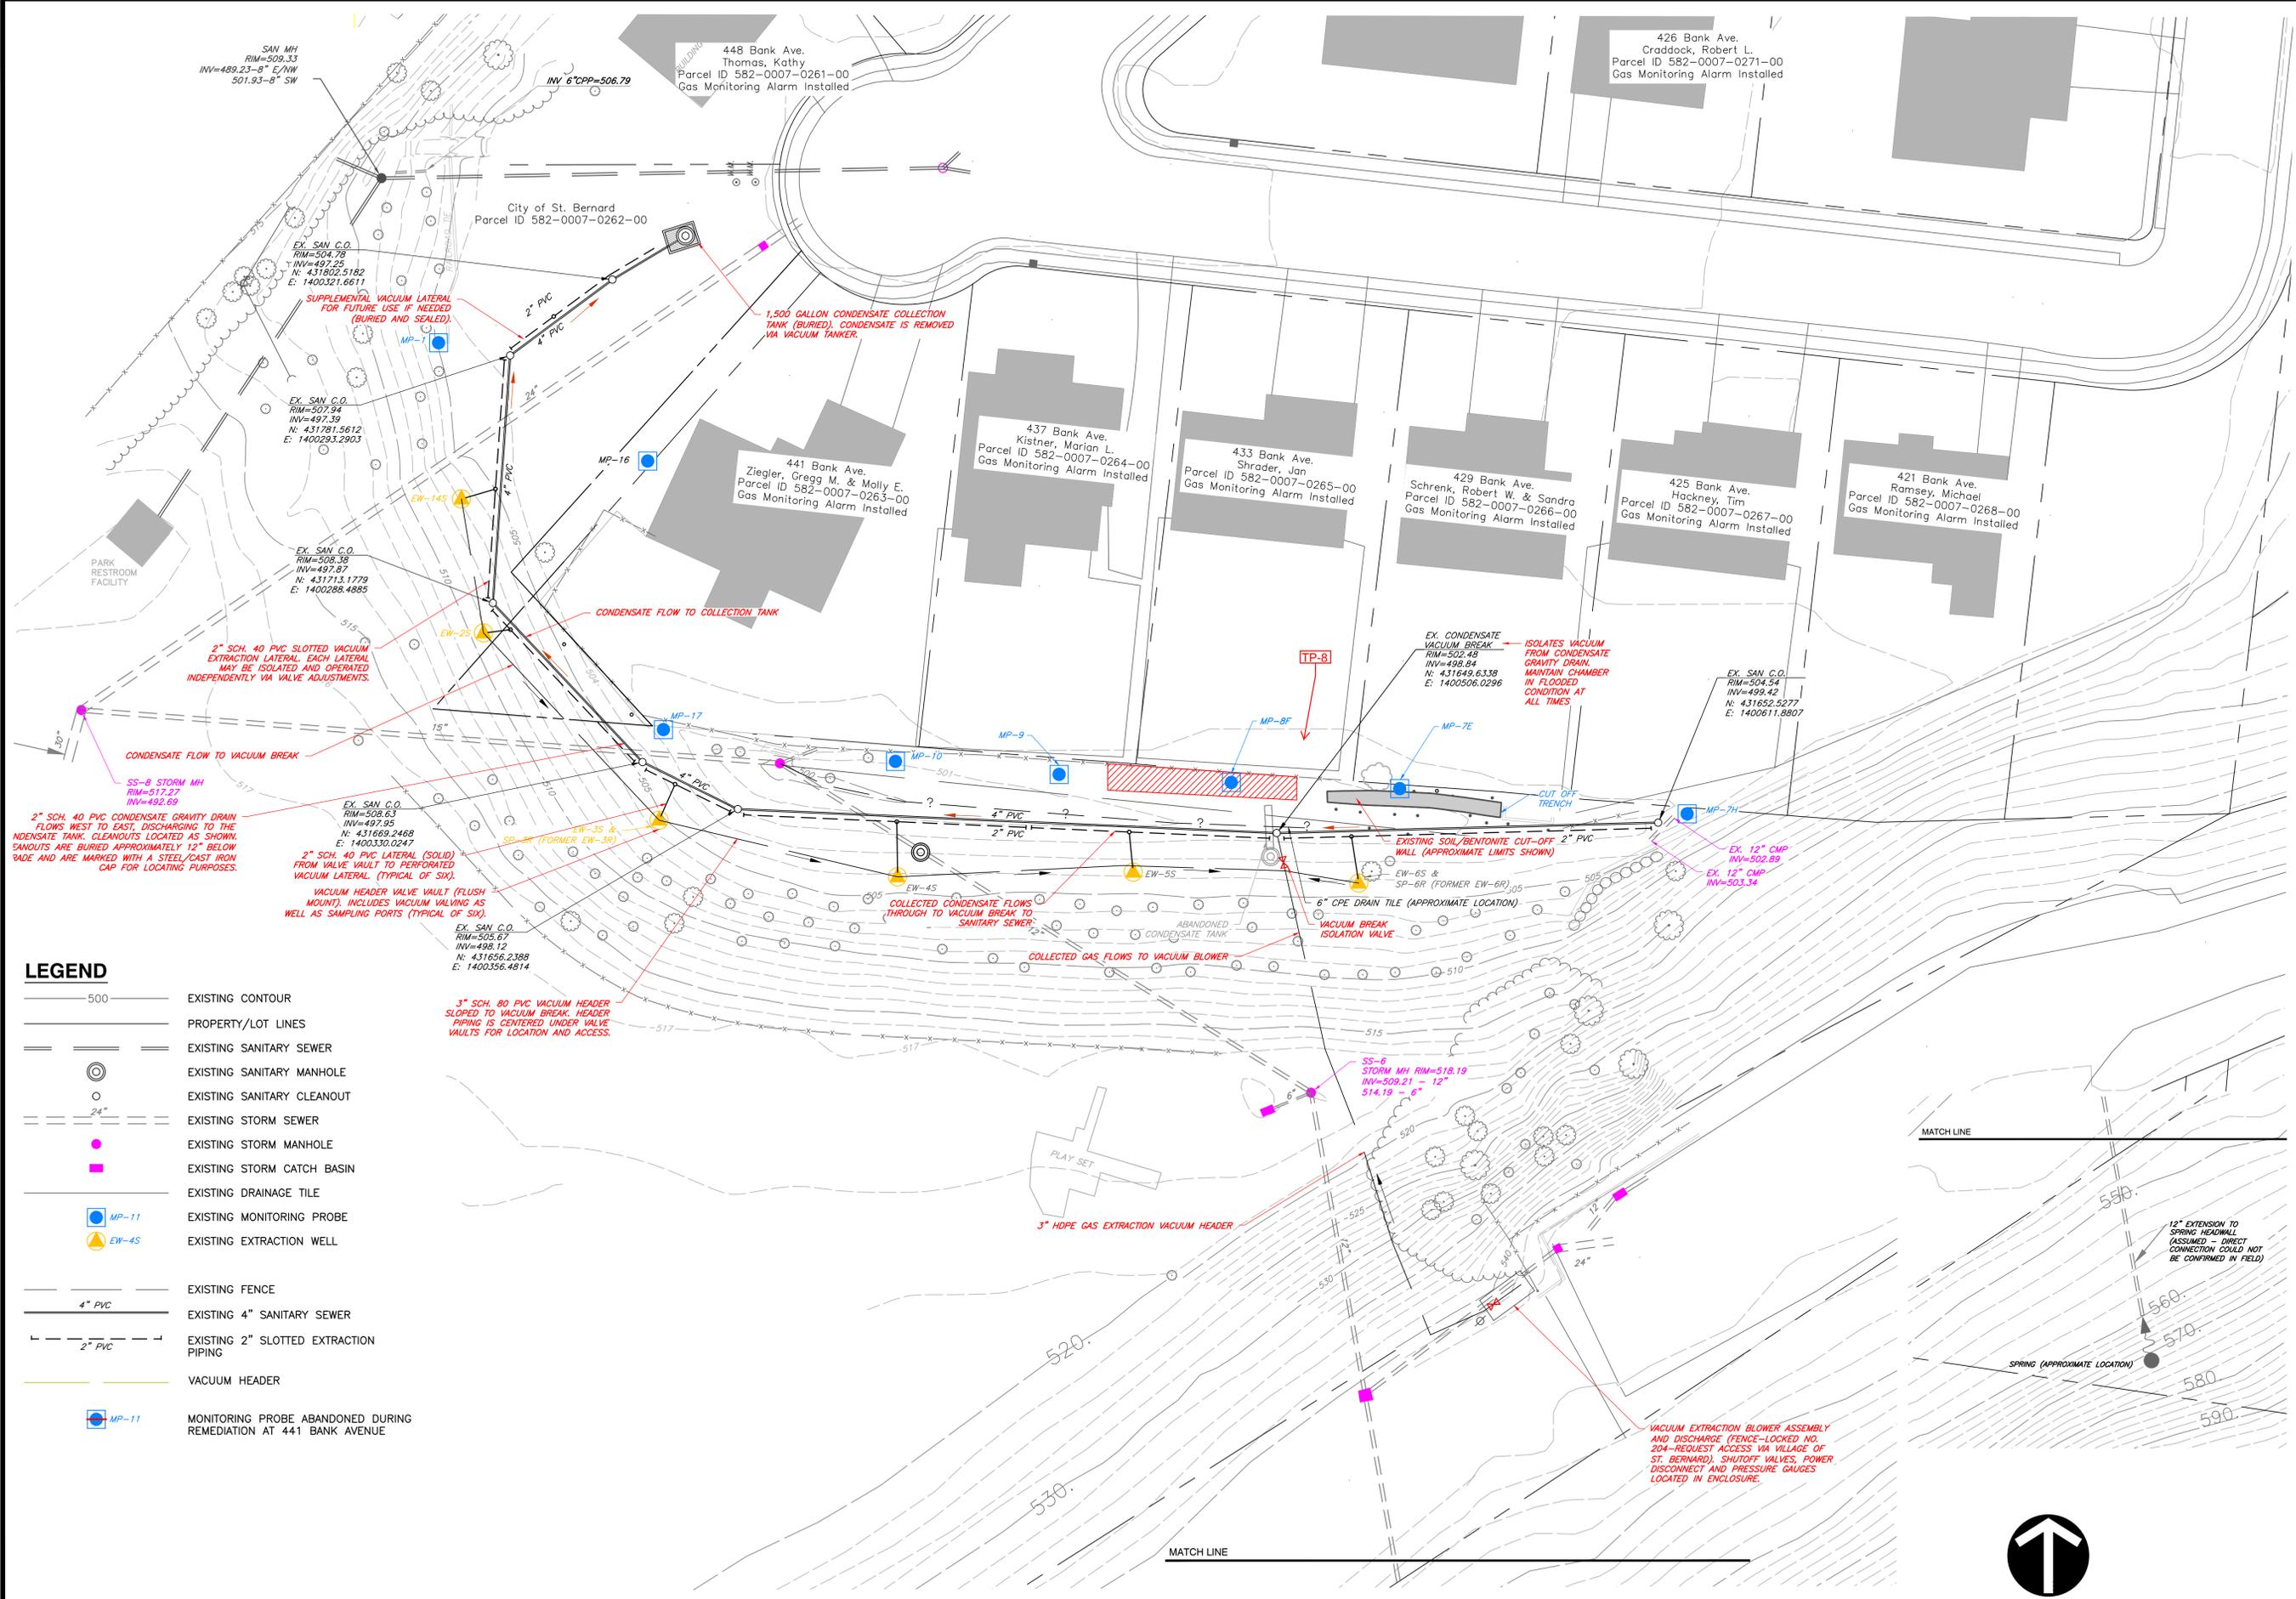
CK. BY	
DESCRIPTION	
REV. DATE	
SHEET TITLE	MONITORING NETWORK
PROJECT TITLE	ST. BERNARD LANDFILL VILLAGE OF ST. BERNARD, OHIO
CLIENT	VILLAGE OF ST. BERNARD 110 WASHINGTON AVENUE ST. BERNARD, OHIO 45217
CADD FILE:	FIG 5
DATE:	SEPTEMBER 2014
SCALE:	AS SHOWN
DRAWING NO.	FIG 1

The monthly monitoring event for the month of December 2015 was performed December 2, 2015. An exceedance of the combustible gas threshold limit (5 percent by volume) was measured in compliance probe MP-8F. The location of MP-8F is shown on Figure 1. The combustible gas concentration for both the initial and sustained readings for both the first monitoring and the verification monitoring was approximately 10 percent. Compliance monitoring was implemented with the required immediate (within 24 hours) notifications to the Village of St. Bernard, the St. Bernard Fire Department, the St. Bernard Police Department, the Hamilton County Health Department, and the Ohio EPA. A copy of the notification is included in Appendix B. The required 7-day report was prepared and submitted to the Village, the Health Department, and the Ohio EPA. This report is being submitted in accordance with OAC 3745-27-12 (E)(5)(g)(iii) to document that the requirements for the discontinuation of contingency monitoring have been met and, as a result, regular monitoring per the EGMP will resume.

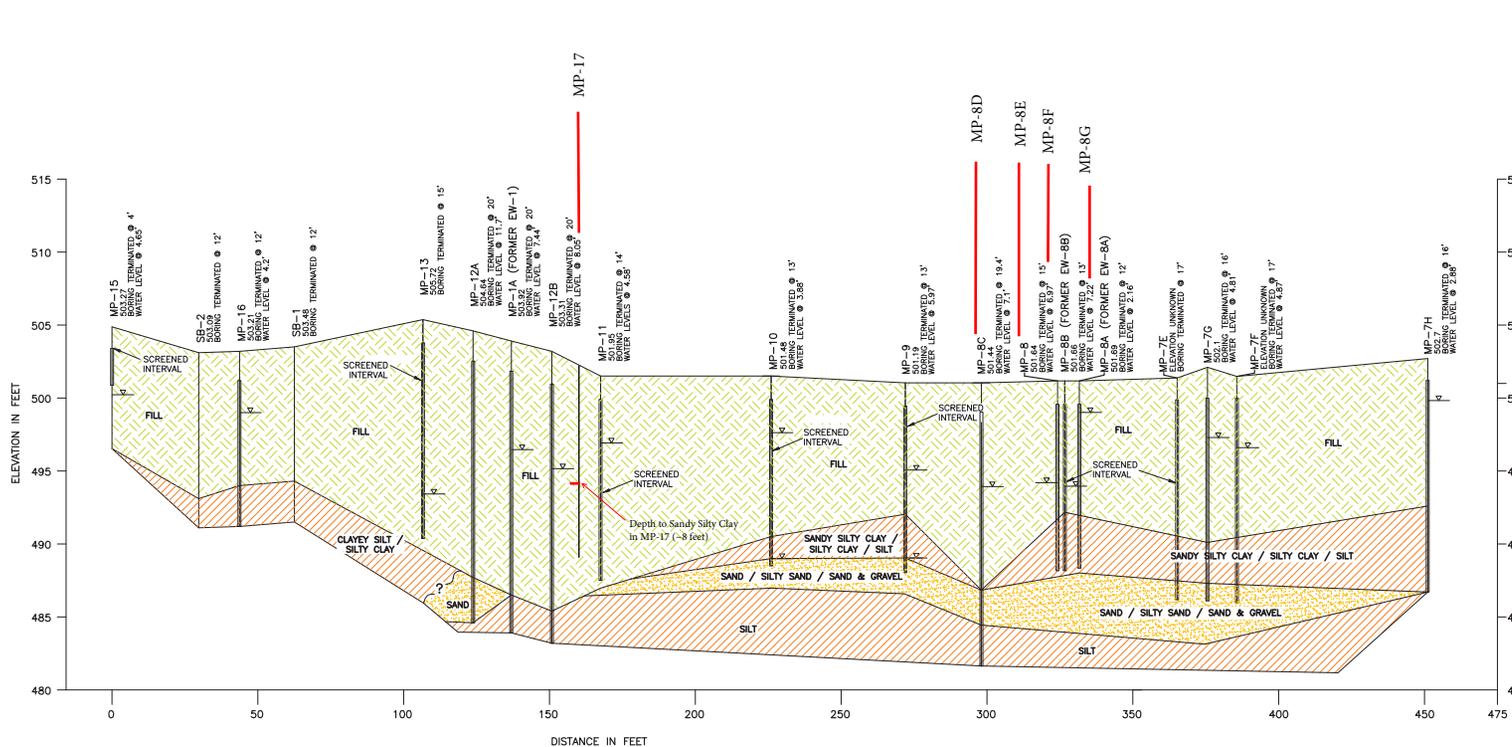
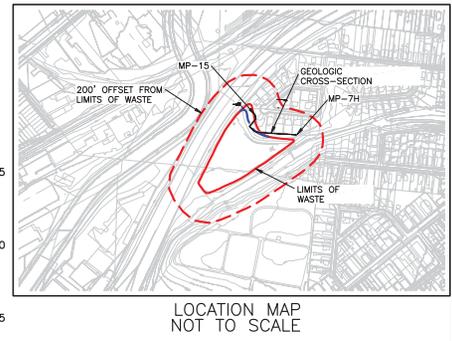
FIGURE 2. CEC 2011 Northern Geologic Cross Section

With respect to site specific geology, the most significant feature includes a glacial till/outwash sequence which appears to form the base of the site. This unit is predominated by low permeability clays and or silts interbedded with silty sands within the areas investigated. Both oxidized and non-oxidized native materials have been found at depth, suggesting deposition in multiple sequences.

Although interbedded sands represent a potential zone of migration, those materials examined via borings were saturated and included a high percentage of silt (estimated at 40 percent or higher). As such, although classified as granular material, the potential for large scale gas transmission is seen as limited.
