## SCS ENGINEERS

December 16, 2016  
File No. 23212007.04

Subject: Village of St. Bernard Landfill  
MP-10 Contingency Monitoring 3<sup>rd</sup> 30-day Report  
MP-9 Contingency Monitoring 7-day Report

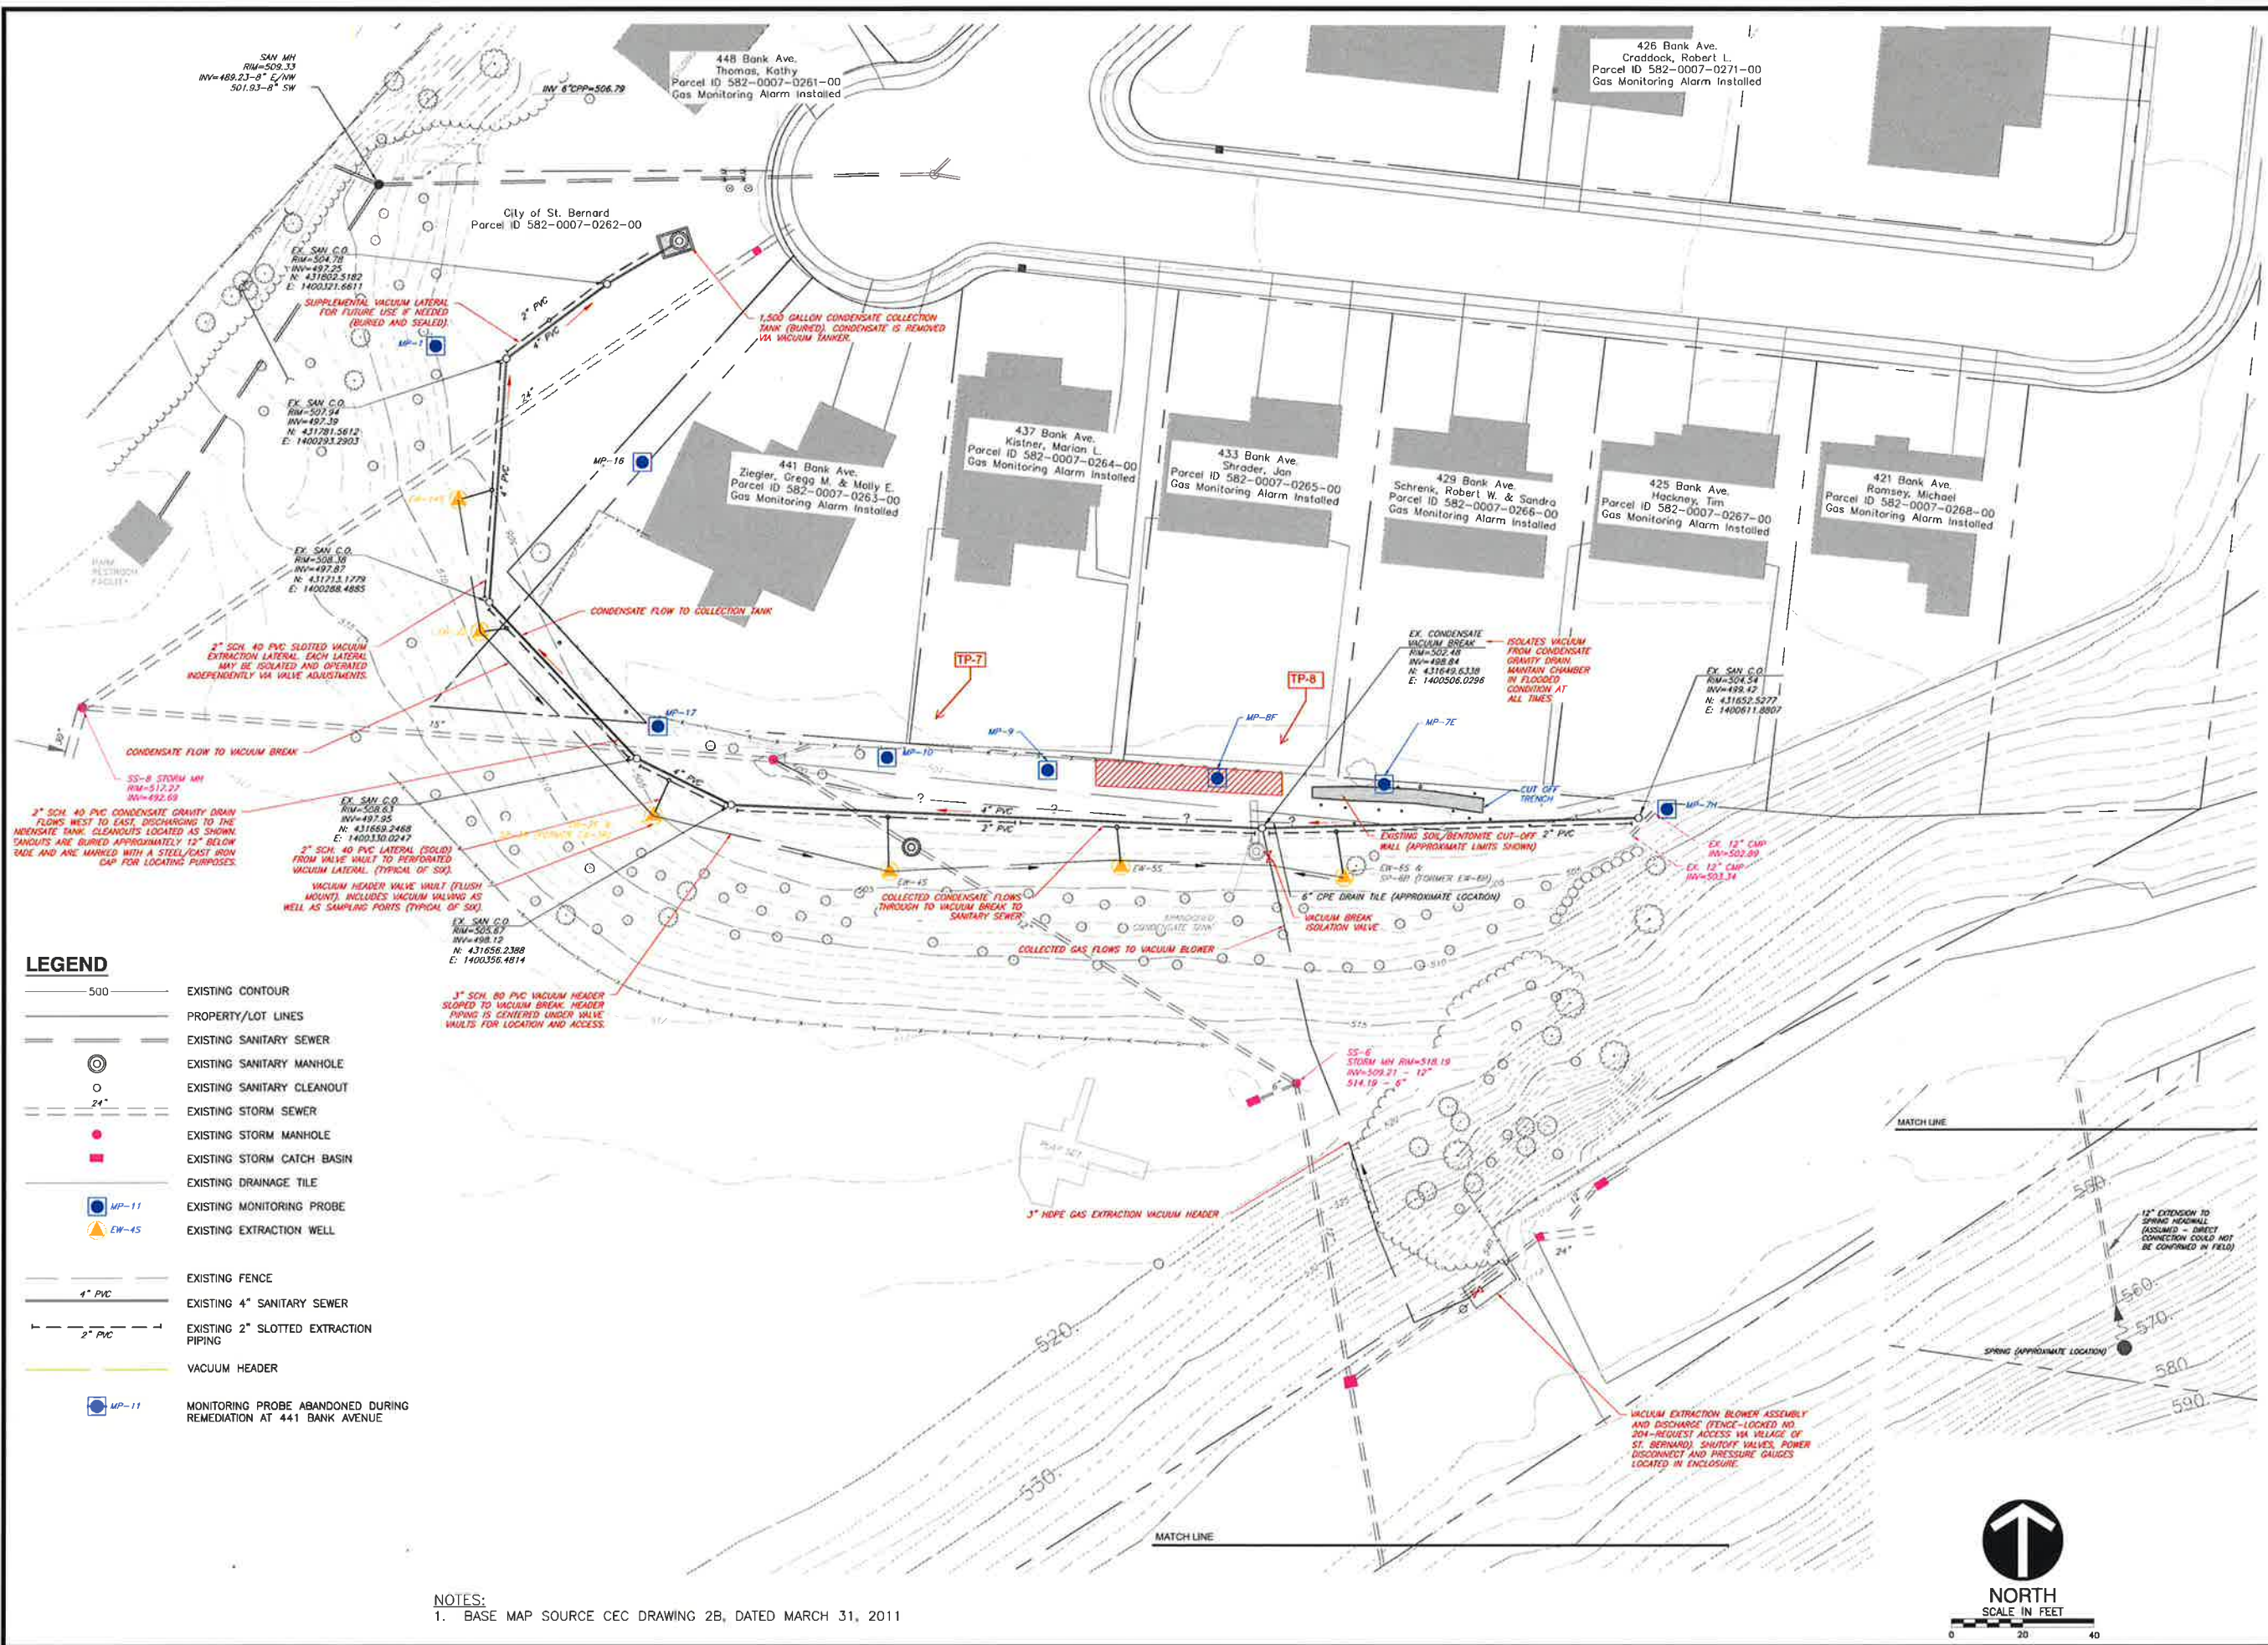
MONITORING NETWORK	
SHEET TITLE	MONITORING NETWORK
PROJECT TITLE	ST. BERNARD LANDFILL VILLAGE OF ST. BERNARD, OHIO
CLIENT	VILLAGE OF ST. BERNARD 110 WASHINGTON AVENUE ST. BERNARD, OHIO 45217
CADD FILE:	FIG 5
DATE:	SEPTEMBER 2014
SCALE:	AS SHOWN
DRAWING NO.	<b>FIG 1</b>

This letter serves as the third 30-day report. A site map is presented as Figure 1 in Attachment A.

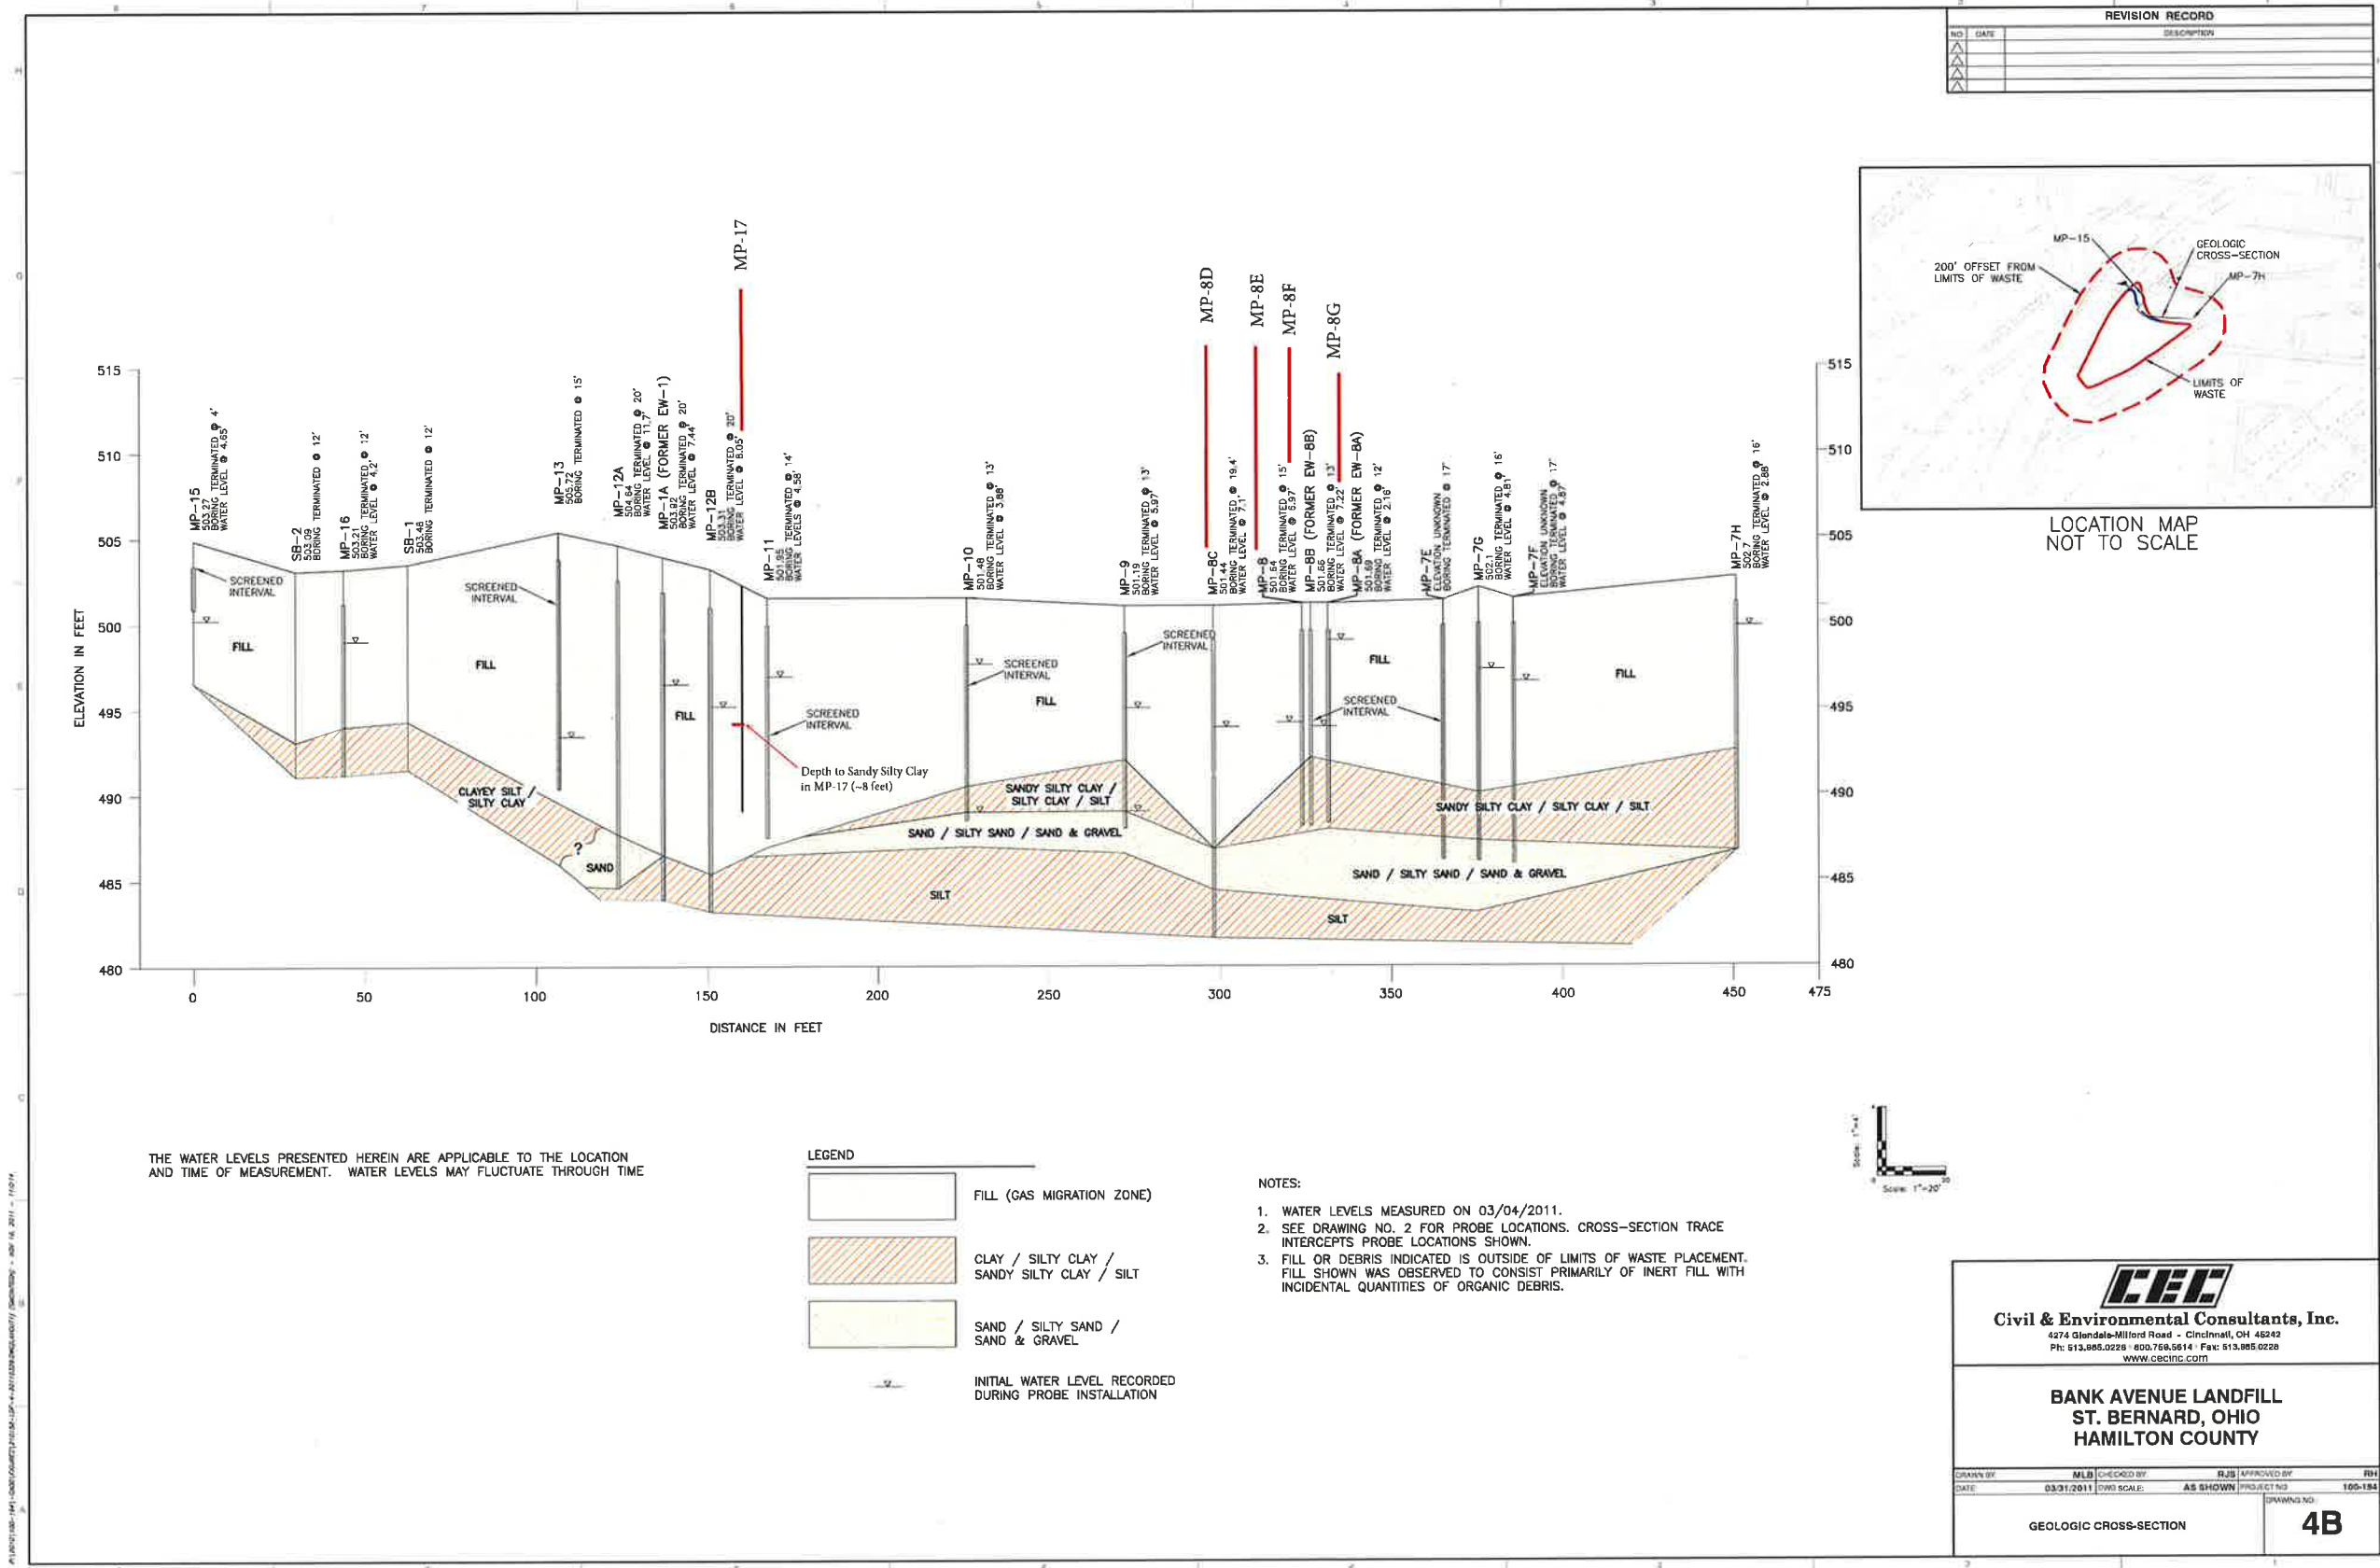
FIGURE 2. CEC 2011 Northern Geologic Cross Section

The description of the site setting and site geology has been summarized from the EGMP. With respect to regional geology, the site is situated on the southeast edge of the Mill Creek Valley. The regional geology reflects multiple glacial advances and is consistent with a glacial outwash valley. Generally, regional geologic sequences consist of glacial valleys incised within Ordovician bedrock formations. These valley fills consist of highly variable interbedded sands, gravels, clays, silts, boulders, and cobbles.

With respect to site specific geology, the most significant feature includes a glacial till/outwash sequence which appears to form the base of the site. This unit is predominated by low permeability clays and or silts interbedded with silty sands within the areas investigated. Both oxidized and non-oxidized native materials have been found at depth, suggesting deposition in multiple sequences.

Although interbedded sands represent a potential zone of migration, those materials examined via borings were saturated and included a high percentage of silt (estimated at 40 percent or higher). As such, although classified as granular material, the potential for large scale gas transmission is seen as limited.

Along the northern perimeter of the site, the former landfill property is contiguous with several residential properties along Bank Avenue. Essentially, this area consists of a flat terrace, projecting out from the toe of the landfill slope and transitioning into the back yards of the Bank Avenue residences. This terrace was raised to its current elevation by the placement of two generations of fill. A cross section along this northern perimeter is presented as Figure 2 in Attachment A. The boring logs used to prepare the cross section are presented in the EGMP. The log for MP-10F is included in this report in Attachment C. The fill soils, in particular the lower fill, contain hard fill and miscellaneous debris. As a result, the near surface geologic profile of this terrace is varied. The fill soil matrix in the vicinity of MP-10 is a sandy silt or sandy clay. The presence of the hard fill and debris likely increases the porosity and results in a porosity that approaches that typically assumed for granular soils, i.e. 25 percent. Recent water level measurements show that the fill soil in the vicinity of MP-10 is saturated at approximately 4 feet below the ground surface. MP-10 is screened from approximately 2 to 12 feet below the ground surface.
